Durability of Sarnafil T polymeric roofing membrane Summary report

December 2014

from Expert report 80740 dated 05 August 2014

Institut für Bautenschutz, Baustoffe und Bauphysik
Dr. Rieche und Dr. Schürger GmbH & Co. KG, 70736 Fellbach, Germany

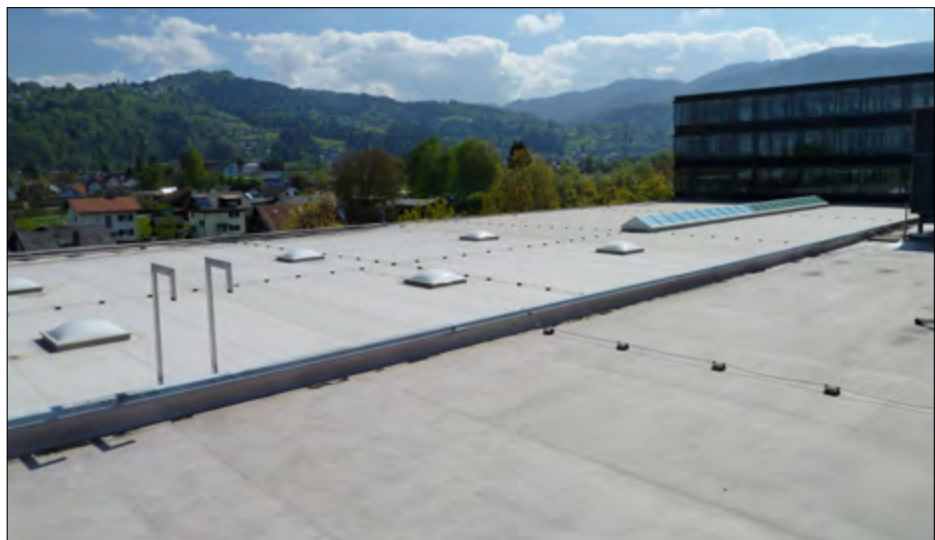
All five of the roofs that we inspected and examined were found to be in good general condition (Pictures 3 and 4). Specifically it was noted that the edge terminations and the flashings at penetrations such as skylights (Picture 4) were all intact.

Fig. 3: Overall view of the roof of the Meusburger Building in Wolfurt (Austria)

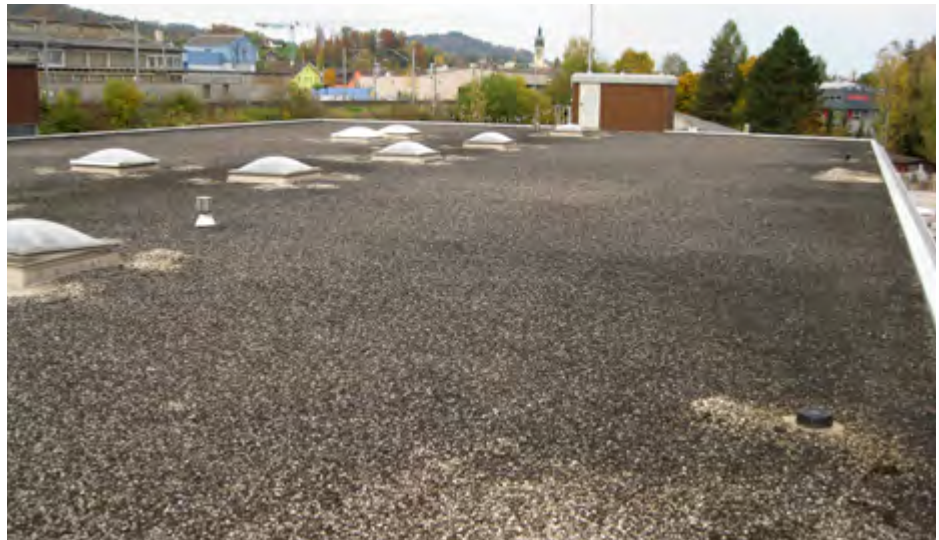
Fig. 4: Overall view of the roof of the Brunner Building in Flawil (Switzerland)

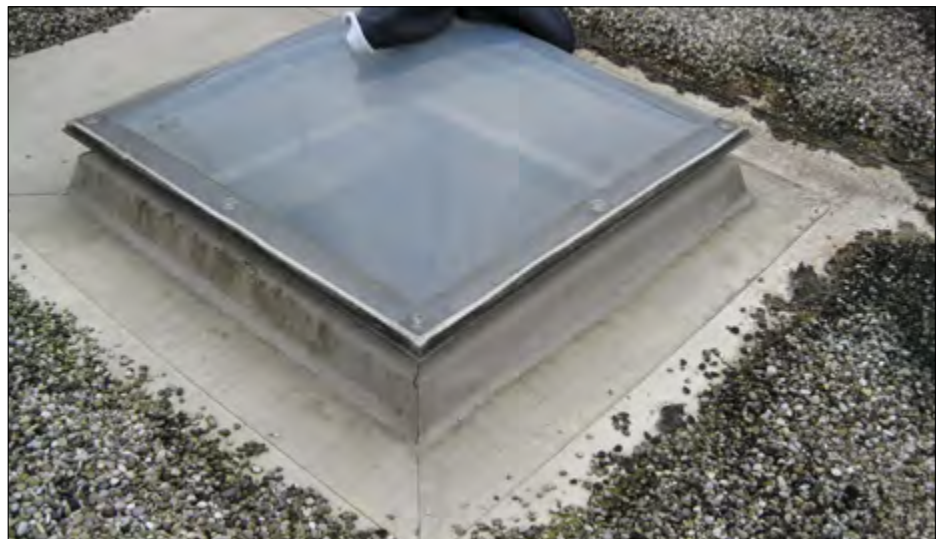
Fig. 5: Flashing at a skylight, roof of Brunner building in Flawil (Switzerland)

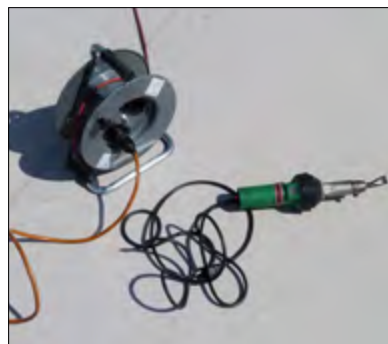
All seams checked with a seam tester were tight. All sampling locations could be patch repaired with no problems, simply by welding according to the standard method statement described in the installation guidelines (Picture 5).

Fig. 6: Hot air welding of new to existing membranes (**Sarnafil® TS 77-18**) Meusburger Building in Wolfurt (Austria)

All the welded seams tested broke outside the seam area as required by the standards. There were no significant changes in this over the different times of exposure. Also the results of tests on the welding seams for new membranes onto the exposed polymeric membranes on the roofs, also confirm this performance and reparability even after up to 25 years.

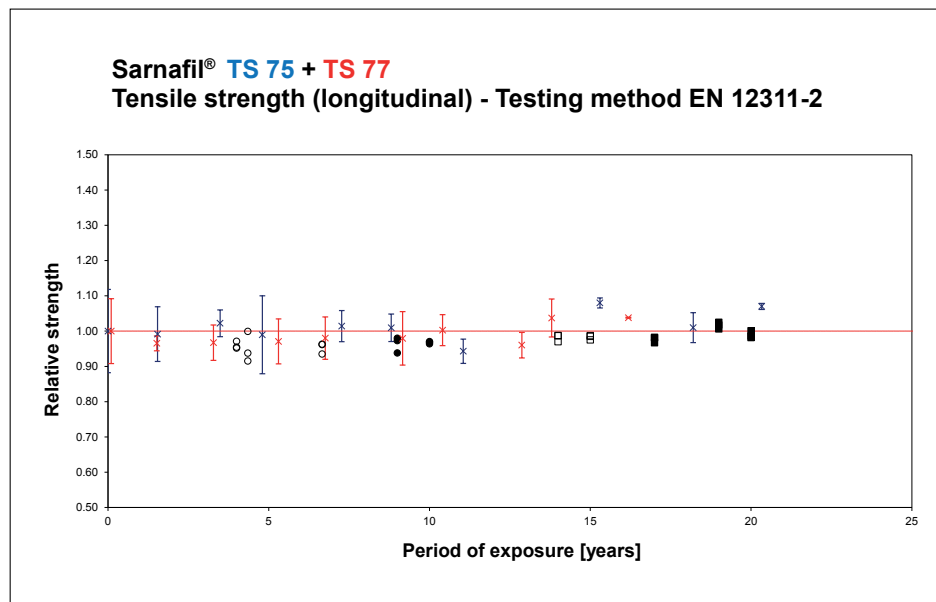
The material investigations of **Sarnafil® TS** showed that the values of the mechanical properties elongation at break and tensile strength, even after more than 20 years exposure on the roofs, lie within the originally expected distribution range for the new material. Hence there has been no significant change of the membrane properties. Fig. 7 and Fig. 8 are representative examples illustrating the measured tensile strength of the **Sarnafil® TS** specimens over time.

Fig. 7: Tensile strength (longitudinal) of Sarnafil® TS after exposure

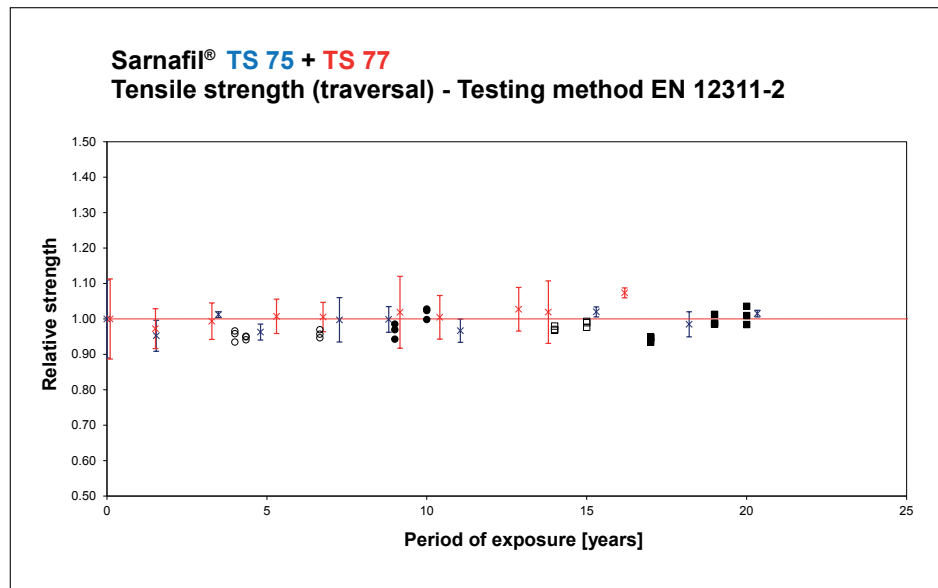
Fig. 8: Tensile strength (traversal) of Sarnafil® TS after exposure

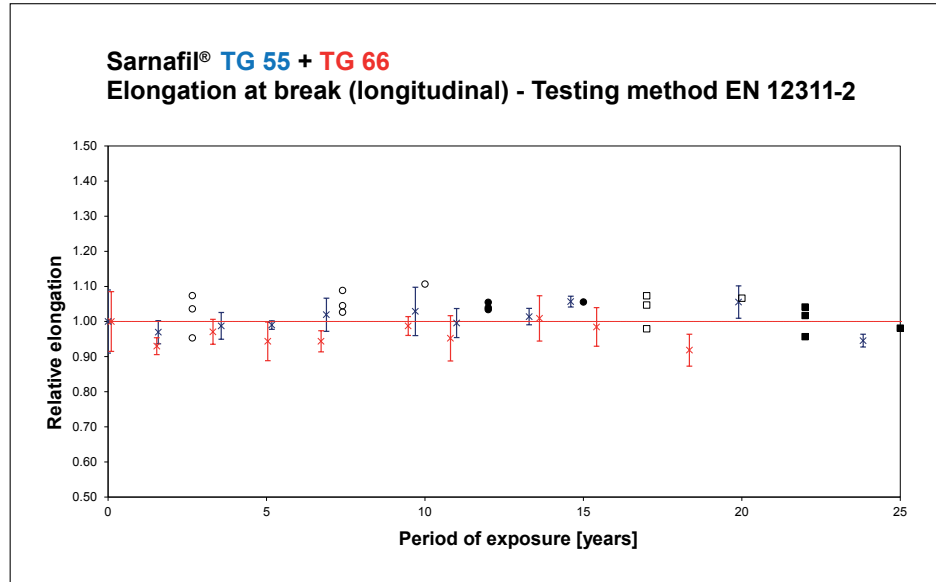
The measured values of elongation at break for **Sarnafil® TG** were similar to the results of **Sarnafil® TS**; i.e. even after up to 25 years of exposure there was no significant change over time (Fig. 9 and Fig. 10: Elongation at break).

Fig. 9: Elongation at break (longitudinal) of Sarnafil® TG after exposure

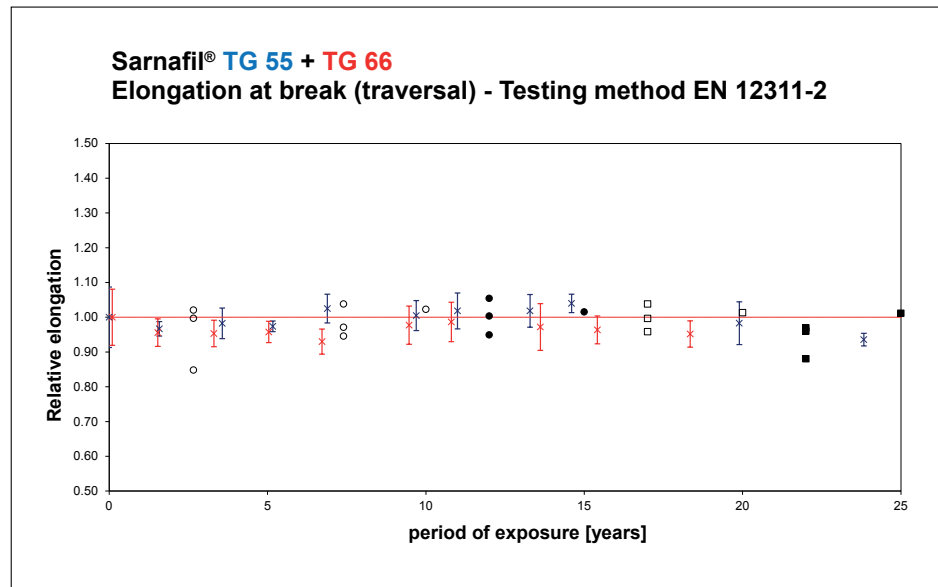
Fig. 10: Elongation at break (traversal) of Sarnafil® TG after exposure

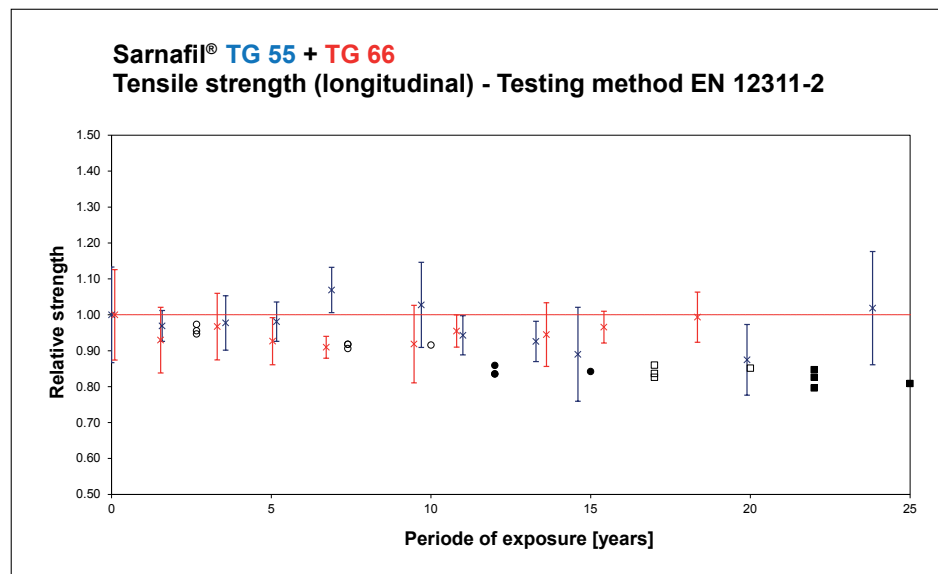
The tensile strength of **Sarnafil® TG** showed a total mean value decrease of 15% after the first 12 years. However, this decrease is significantly slower over the following years.

Fig. 11: Tensile strength (longitudinal) of Sarnafil® TG after exposure

A difference in the tensile strength was observed and this decrease is time related. In our previous studies a maximum decrease of 15% of the tensile strength after 12 years was found. Considering the results from 2009, the last five years show a much slower reduction of the tensile strength during this period in comparison to the reduction during the first 12 years, as the maximum reduction of the tensile strength measured after 25 years was 20%.

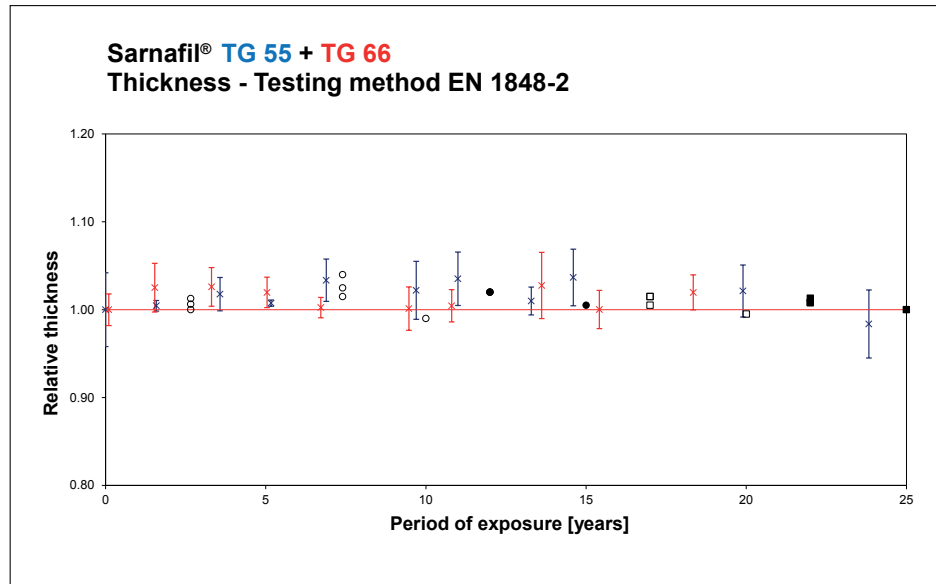
For both **Sarnafil® TG** and **Sarnafil® TS** no significant change in the material thickness was found due to their exposure on the roofs.

Fig. 12: Thickness of Sarnafil® TG after exposure

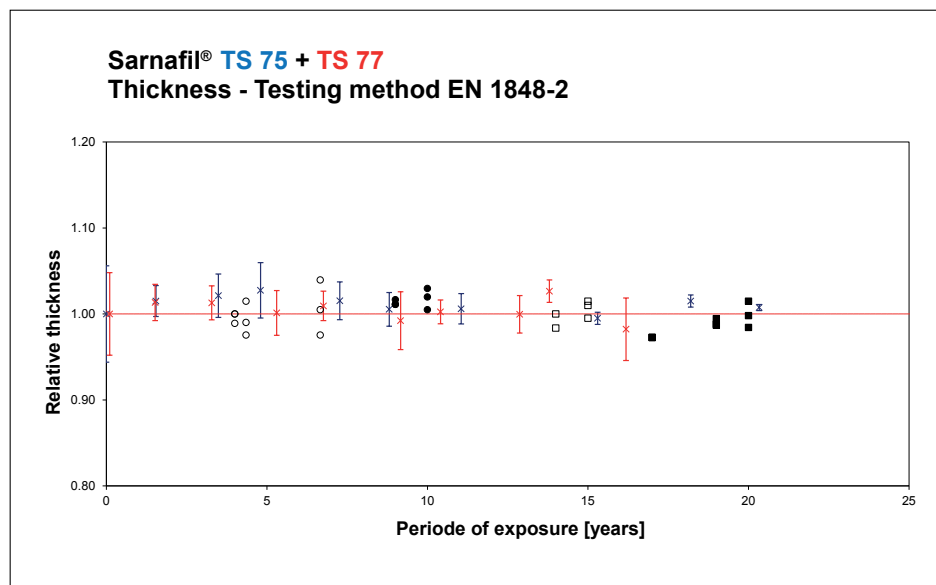
Fig. 13: Thickness of Sarnafil® TS after exposure
