Durability of Sarnafil T polymeric roofing membrane Summary report

December 2014

from Expert report 80740 dated 05 August 2014

Institut für Bautenschutz, Baustoffe und Bauphysik
Dr. Rieche und Dr. Schürger GmbH & Co. KG, 70736 Fellbach, Germany

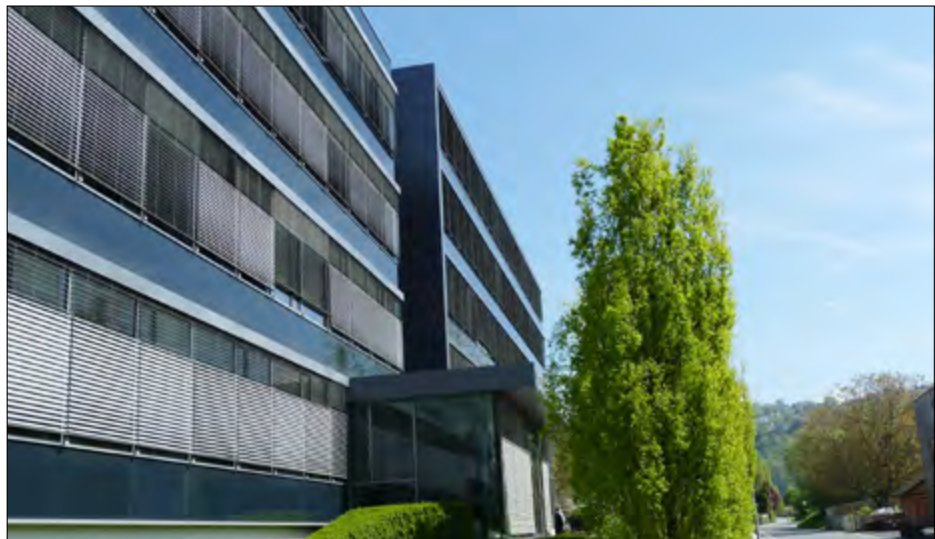
All five of the roofs that we inspected and examined were found to be in good general condition (Pictures 3 and 4). Specifically it was noted that the edge terminations and the flashings at penetrations such as skylights (Picture 4) were all intact.

Fig. 2: Front view of the Meusburger Building in Wolfurt (Austria)
